Ref: OGCAA3591 – Parliament House Darwin

ASBESTOS MANAGEMENT PLAN FOR Parliament House Darwin

**NORTHERN TERRITORY PARLIAMENT
HOUSE**

ASBESTOS MANAGEMENT PLAN

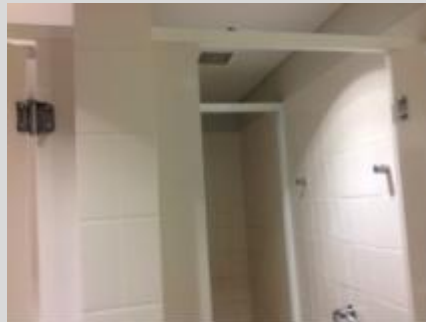
Elevation:	Level 1	Quantity:	2 - m2	Sample #:	Similar to 27296	
Position Installed:	Other - Refer to Comments	Condition:	-	Sample Result:	No Asbestos Detected	
Primary Location:	A8 - Gym change room (female)	Friability:	-	Risk Rating:		
Secondary Location:	Partitions	Surface Treatment:	-	Recommendation:	-	
Comments:	Toilet partitions					Urgent Action Required? -

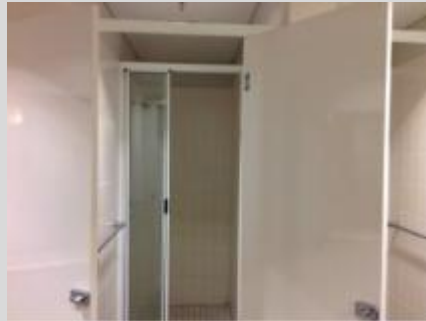
Elevation:	Level 1	Quantity:	8 - m2	Sample #:	Similar to 27297	
Position Installed:	Other - Refer to Comments	Condition:	-	Sample Result:	No Asbestos Detected	
Primary Location:	A8 - Gym change room (female)	Friability:	-	Risk Rating:		
Secondary Location:	Toilet doors	Surface Treatment:	-	Recommendation:	-	
Comments:	Epoxy coated timber					Urgent Action Required? -

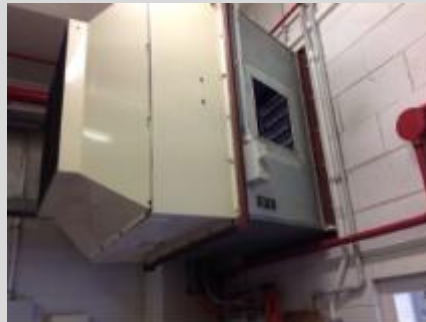
Elevation:	Level 1	Quantity:	2 - lm	Sample #:	27293	
Position Installed:	Membrane	Condition:	-	Sample Result:	No Asbestos Detected	
Primary Location:	C4 - Water pump room	Friability:	-	Risk Rating:		
Secondary Location:	Sealant to exhaust fan ductwork	Surface Treatment:	-	Recommendation:	-	
Comments:						Urgent Action Required? -

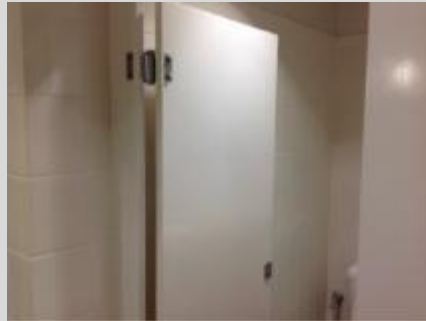
Elevation:	Level 1	Quantity:	21 - m2	Sample #:	Similar to 27297	
Position Installed:	Other - Refer to Comments	Condition:	-	Sample Result:	No Asbestos Detected	
Primary Location:	G4 - Public toilets (female)	Friability:	-	Risk Rating:		
Secondary Location:	Toilet doors	Surface Treatment:	-	Recommendation:	-	
Comments:	Epoxy coated timber					Urgent Action Required? -

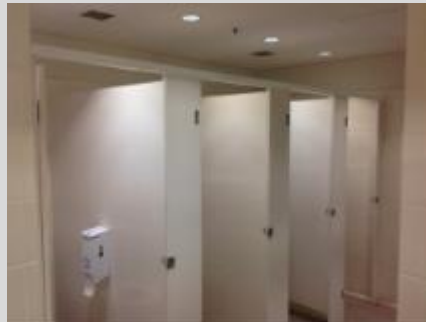
Elevation:	Level 1	Quantity:	20 - m2	Sample #:	Similar to 27296	
Position Installed:	Other - Refer to Comments	Condition:	-	Sample Result:	No Asbestos Detected	
Primary Location:	G4 - Public toilets (female)	Friability:	-	Risk Rating:		
Secondary Location:	Partitions	Surface Treatment:	-	Recommendation:	-	
Comments:	Toilet partitions					Urgent Action Required? -

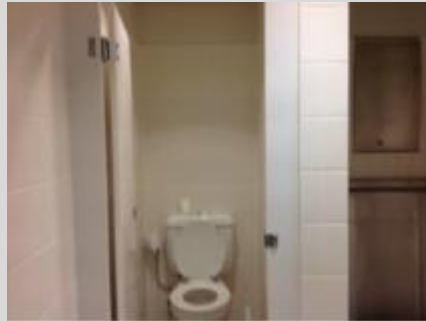
Elevation:	Level 1	Quantity:	1 - m2	Sample #:	Similar to 27296	
Position Installed:	Other - Refer to Comments	Condition:	-	Sample Result:	No Asbestos Detected	
Primary Location:	G8 - Staff toilets (male)	Friability:	-	Risk Rating:		
Secondary Location:	Partitions	Surface Treatment:	-	Recommendation:	-	
Comments:	Toilet partitions					Urgent Action Required? -

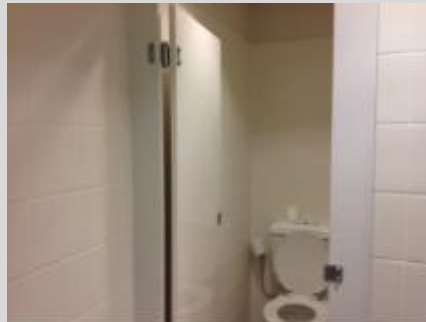
Elevation:	Level 1	Quantity:	2.5 - m2	Sample #:	Similar to 27297	
Position Installed:	Other - Refer to Comments	Condition:	-	Sample Result:	No Asbestos Detected	
Primary Location:	G8 - Staff toilets (male)	Friability:	-	Risk Rating:		
Secondary Location:	Toilet door	Surface Treatment:	-	Recommendation:	-	
Comments:	Epoxy coated timber					Urgent Action Required? -

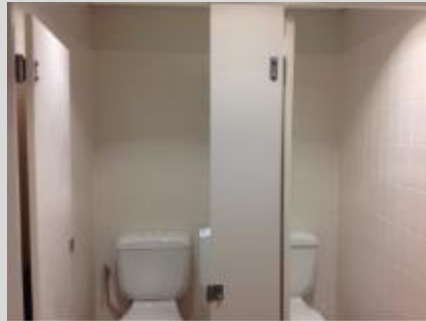
Elevation:	Level 1	Quantity:	5 - m2	Sample #:	27296	
Position Installed:	Other - Refer to Comments	Condition:	-	Sample Result:	No Asbestos Detected	
Primary Location:	G9 - Staff toilets (female)	Friability:	-	Risk Rating:		
Secondary Location:	Partitions	Surface Treatment:	-	Recommendation:	-	
Comments:	Toilet partitions					Urgent Action Required? -

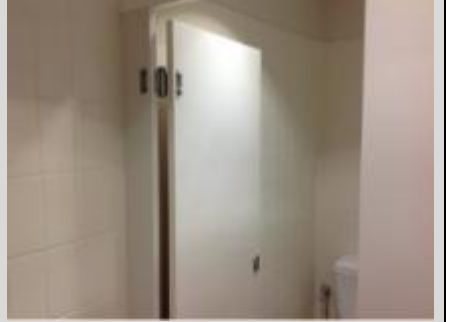
Elevation:	Level 1	Quantity:	5 - m2	Sample #:	27297	
Position Installed:	Other - Refer to Comments	Condition:	-	Sample Result:	No Asbestos Detected	
Primary Location:	G9 - Staff toilets (female)	Friability:	-	Risk Rating:		
Secondary Location:	Toilet doors	Surface Treatment:	-	Recommendation:	-	
Comments:	Epoxy coated timber					Urgent Action Required? -

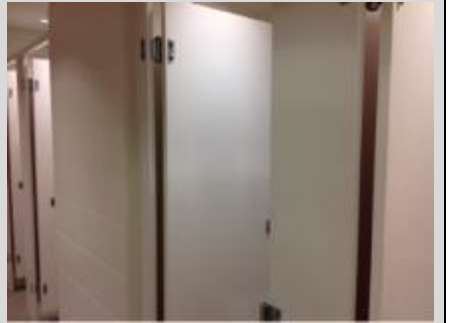
Elevation:	Level 1	Quantity:	10 - m2	Sample #:	Similar to 27297	
Position Installed:	Other - Refer to Comments	Condition:	-	Sample Result:	No Asbestos Detected	
Primary Location:	H2 - Public toilets (male)	Friability:	-	Risk Rating:		
Secondary Location:	Toilet door	Surface Treatment:	-	Recommendation:	-	
Comments:	Epoxy coated timber					Urgent Action Required? -

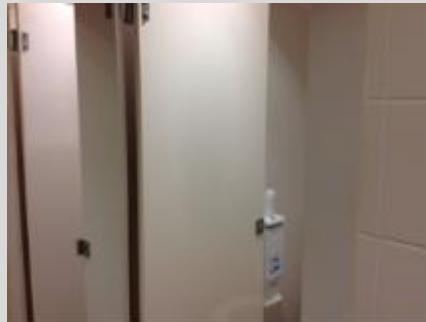
Elevation:	Level 1	Quantity:	8 - m2	Sample #:	Similar to 27296	
Position Installed:	Other - Refer to Comments	Condition:	-	Sample Result:	No Asbestos Detected	
Primary Location:	H2 - Public toilets (male)	Friability:	-	Risk Rating:		
Secondary Location:	Partitions	Surface Treatment:	-	Recommendation:	-	
Comments:	Toilet partitions					Urgent Action Required? -

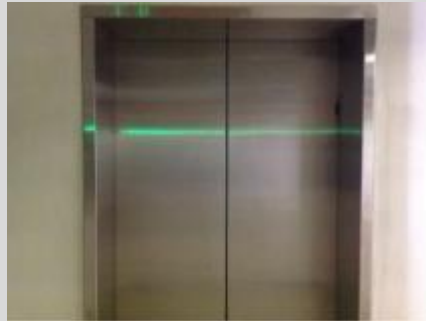
Elevation:	Level 1	Quantity:	0 - m2	Sample #:	-	
Position Installed:	Insulation / Fill	Condition:	Unknown	Sample Result:	-	
Primary Location:	Lift 5 - Goods lift	Friability:	Unknown	Risk Rating:	5 - Moderate	
Secondary Location:	Fire proofing inside doors	Surface Treatment:	Unknown	Recommendation:	Manage & Review	
Comments:	Only authorised elevator maintenance technicians to access. If technician is to access, please contact Octief to discuss management and update details of register and management plan.					Urgent Action Required? No

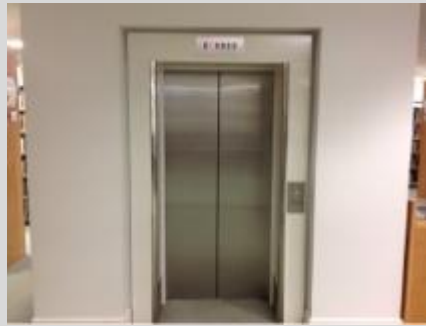
Elevation:	Level 1	Quantity:	0 - m2	Sample #:	-	
Position Installed:	Insulation / Fill	Condition:	Unknown	Sample Result:	-	
Primary Location:	Lift 6 - Library	Friability:	Unknown	Risk Rating:	5 - Moderate	
Secondary Location:	Fire proofing inside doors	Surface Treatment:	Unknown	Recommendation:	Manage & Review	
Comments:	Only authorized elevator maintenance technicians to access. If technician is to access, please contact Octief to discuss management and update details of register and management plan.					Urgent Action Required?
						No

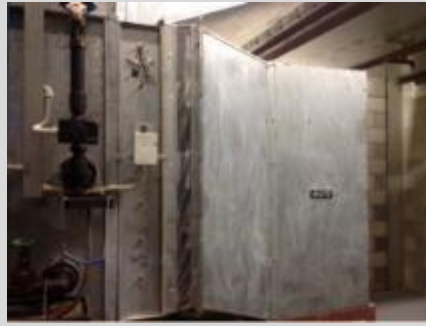
Elevation:	Level 1	Quantity:	25 - lm	Sample #:	Similar to 27292	
Position Installed:	Membrane	Condition:	-	Sample Result:	No Asbestos Detected	
Primary Location:	Plant room 3 - AHU 73	Friability:	-	Risk Rating:		
Secondary Location:	Mastic to ductwork	Surface Treatment:	-	Recommendation:	-	
Comments:						Urgent Action Required?
						-

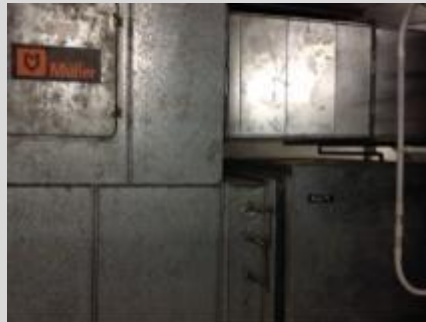
Elevation:	Level 1	Quantity:	50 - lm	Sample #:	Similar to 27292	
Position Installed:	Membrane	Condition:	-	Sample Result:	No Asbestos Detected	
Primary Location:	Plantroom 4 - AHU 71	Friability:	-	Risk Rating:		
Secondary Location:	Mastic to ductwork	Surface Treatment:	-	Recommendation:	-	
Comments:						Urgent Action Required? -

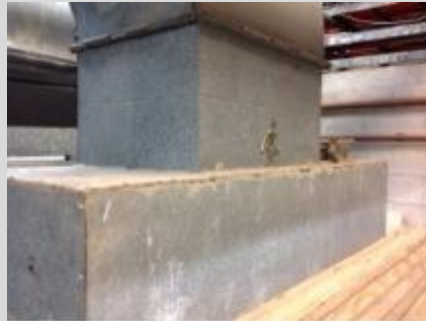
Elevation:	Level 1	Quantity:	3 - lm	Sample #:	Similar to 27292	
Position Installed:	Membrane	Condition:	-	Sample Result:	No Asbestos Detected	
Primary Location:	Plantroom 6 - AHU 16	Friability:	-	Risk Rating:		
Secondary Location:	Leak sealant to ductwork	Surface Treatment:	-	Recommendation:	-	
Comments:						Urgent Action Required? -

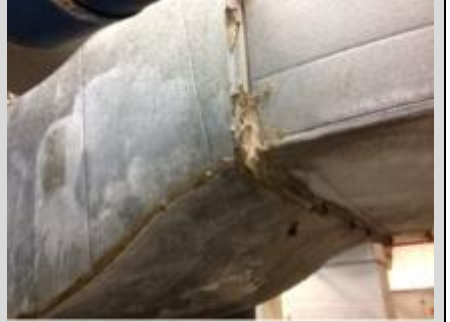
Elevation:	Level 1	Quantity:	150 - lm	Sample #:	27292	
Position Installed:	Membrane	Condition:	-	Sample Result:	No Asbestos Detected	
Primary Location:	Plantroom 6 - AHU 24	Friability:	-	Risk Rating:		
Secondary Location:	Leak sealant to ductwork	Surface Treatment:	-	Recommendation:	-	
Comments:						Urgent Action Required? -

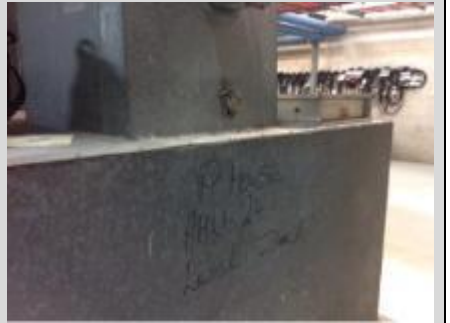
Elevation:	Level 1	Quantity:	150 - lm	Sample #:	27291	
Position Installed:	Membrane	Condition:	-	Sample Result:	No Asbestos Detected	
Primary Location:	Plantroom 6 - All chiller plant AHUs	Friability:	-	Risk Rating:		
Secondary Location:	Joint sealant	Surface Treatment:	-	Recommendation:	-	
Comments:						Urgent Action Required? -

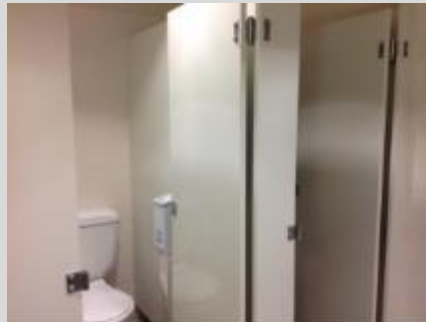
Elevation:	Level 2	Quantity:	9 - m2	Sample #:	Similar to 27297	
Position Installed:	Other - Refer to Comments	Condition:	-	Sample Result:	No Asbestos Detected	
Primary Location:	A7 - .Parliamentary toilets (male)	Friability:	-	Risk Rating:		
Secondary Location:	Toilet doors	Surface Treatment:	-	Recommendation:	-	
Comments:	Epoxy coated timber					Urgent Action Required? -

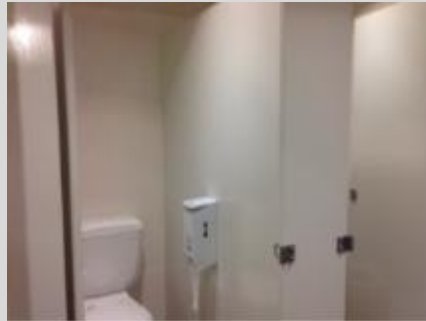
Elevation:	Level 2	Quantity:	8 - m2	Sample #:	Similar to 27296	
Position Installed:	Other - Refer to Comments	Condition:	-	Sample Result:	No Asbestos Detected	
Primary Location:	A7 - Parliamentary toilets (male)	Friability:	-	Risk Rating:		
Secondary Location:	Partitions	Surface Treatment:	-	Recommendation:	-	
Comments:	Toilet partitions					Urgent Action Required? -

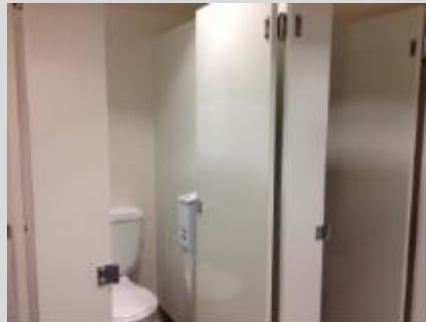
Elevation:	Level 2	Quantity:	12 - m2	Sample #:	Similar to 27296	
Position Installed:	Other - Refer to Comments	Condition:	-	Sample Result:	No Asbestos Detected	
Primary Location:	A9 - Parliamentary toilets (female)	Friability:	-	Risk Rating:		
Secondary Location:	Partitions	Surface Treatment:	-	Recommendation:	-	
Comments:	Toilet partitions					Urgent Action Required? -

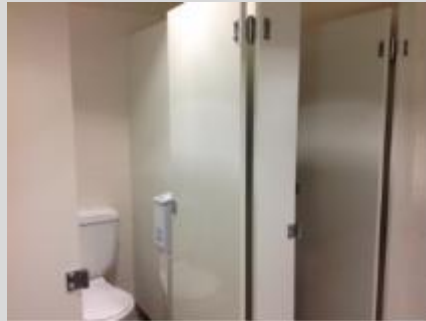
Elevation:	Level 2	Quantity:	9 - m2	Sample #:	Similar to 27297	
Position Installed:	Other - Refer to Comments	Condition:	-	Sample Result:	No Asbestos Detected	
Primary Location:	A9 - Parliamentary toilets (female)	Friability:	-	Risk Rating:		
Secondary Location:	Toilet doors	Surface Treatment:	-	Recommendation:	-	
Comments:	Epoxy coated timber					Urgent Action Required? -

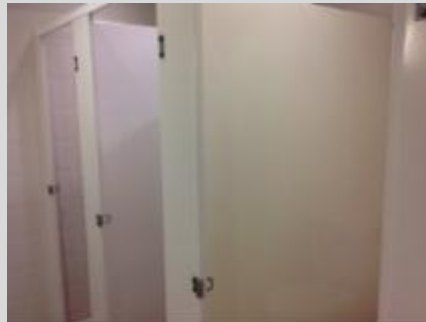
Elevation:	Level 2	Quantity:	25 - m2	Sample #:	Similar to 27296	
Position Installed:	Other - Refer to Comments	Condition:	-	Sample Result:	No Asbestos Detected	
Primary Location:	E8 - Library toilets (male)	Friability:	-	Risk Rating:		
Secondary Location:	Partitions	Surface Treatment:	-	Recommendation:	-	
Comments:	Toilet partitions					Urgent Action Required? -

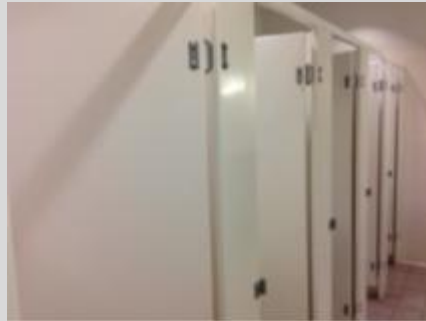
Elevation:	Level 2	Quantity:	18 - m2	Sample #:	Similar to 27297	
Position Installed:	Other - Refer to Comments	Condition:	-	Sample Result:	No Asbestos Detected	
Primary Location:	E8 - Library toilets (male)	Friability:	-	Risk Rating:		
Secondary Location:	Toilet doors	Surface Treatment:	-	Recommendation:	-	
Comments:	Epoxy coated timber					Urgent Action Required? -

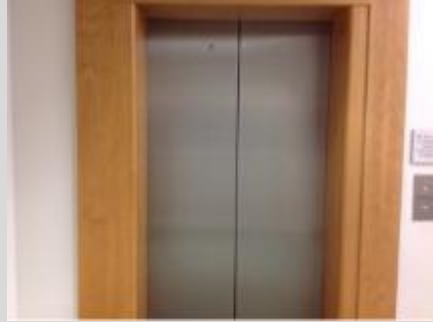
Elevation:	Level 2	Quantity:	0 - m2	Sample #:	-	
Position Installed:	Insulation / Fill	Condition:	Unknown	Sample Result:	-	
Primary Location:	Lift 1	Friability:	Unknown	Risk Rating:	5 - Moderate	
Secondary Location:	Fire proofing inside doors	Surface Treatment:	Unknown	Recommendation:	Manage & Review	
Comments:	Only authorized elevator maintenance technicians to access. If technician is to access, please contact Octief to discuss management and update details of register and management plan.					Urgent Action Required?
						No

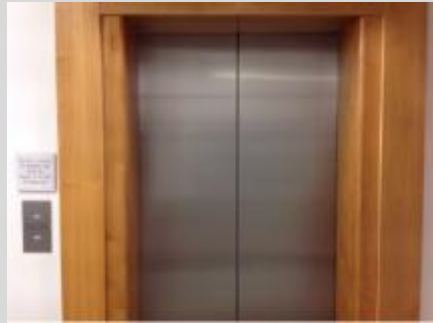
Elevation:	Level 2	Quantity:	0 - m2	Sample #:	-	
Position Installed:	Insulation / Fill	Condition:	Unknown	Sample Result:	-	
Primary Location:	Lift 2	Friability:	Unknown	Risk Rating:	5 - Moderate	
Secondary Location:	Fire proofing inside doors	Surface Treatment:	Unknown	Recommendation:	Manage & Review	
Comments:	Only authorized elevator maintenance technicians to access. If technician is to access, please contact Octief to discuss management and update details of register and management plan.					Urgent Action Required?
						No

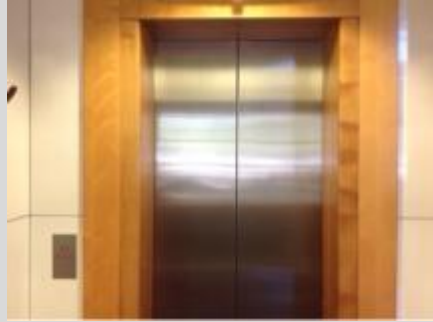
Elevation:	Level 2	Quantity:	0 - m2	Sample #:	-	
Position Installed:	Insulation / Fill	Condition:	Unknown	Sample Result:	-	
Primary Location:	Lift 3	Friability:	Unknown	Risk Rating:	5 - Moderate	
Secondary Location:	Fire proofing inside doors	Surface Treatment:	Unknown	Recommendation:	Manage & Review	
Comments:	Only authorized elevator maintenance technicians to access. If technician is to access, please contact Octief to discuss management and update details of register and management plan.					Urgent Action Required?
						No

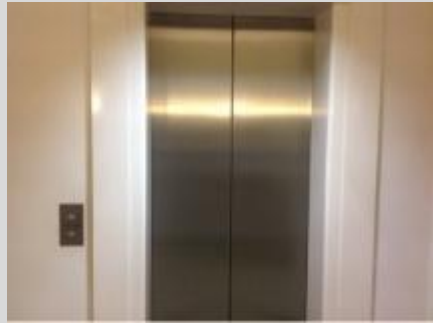
Elevation:	Level 2	Quantity:	0 - m2	Sample #:	-	
Position Installed:	Insulation / Fill	Condition:	Unknown	Sample Result:	-	
Primary Location:	Lift 4	Friability:	Unknown	Risk Rating:	5 - Moderate	
Secondary Location:	Fire proofing inside doors	Surface Treatment:	Unknown	Recommendation:	Manage & Review	
Comments:	Only authorized elevator maintenance technicians to access. If technician is to access, please contact Octief to discuss management and update details of register and management plan.					Urgent Action Required?
						No

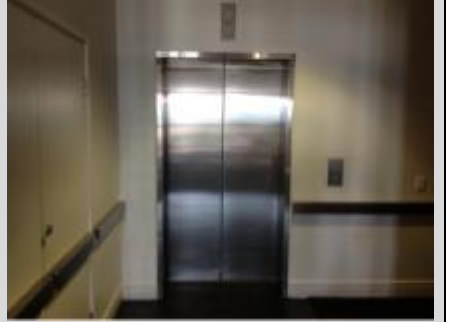
Elevation:	Level 2	Quantity:	0 - m2	Sample #:	-	
Position Installed:	Insulation / Fill	Condition:	Unknown	Sample Result:	-	
Primary Location:	Lift 5 - Goods lift	Friability:	Unknown	Risk Rating:	5 - Moderate	
Secondary Location:	Fire proofing inside doors	Surface Treatment:	Unknown	Recommendation:	Manage & Review	
Comments:	Only authorized elevator maintenance technicians to access. If technician is to access, please contact Octief to discuss management and update details of register and management plan.					Urgent Action Required?
						No

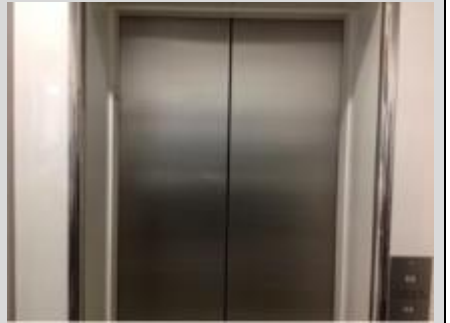
Elevation:	Level 2	Quantity:	0 - m2	Sample #:	-	
Position Installed:	Insulation / Fill	Condition:	Unknown	Sample Result:	-	
Primary Location:	Lift 6 - Library	Friability:	Unknown	Risk Rating:	5 - Moderate	
Secondary Location:	Fire proofing inside doors	Surface Treatment:	Unknown	Recommendation:	Manage & Review	
Comments:	Only authorized elevator maintenance technicians to access. If technician is to access, please contact Octief to discuss management and update details of register and management plan.					Urgent Action Required?
						No

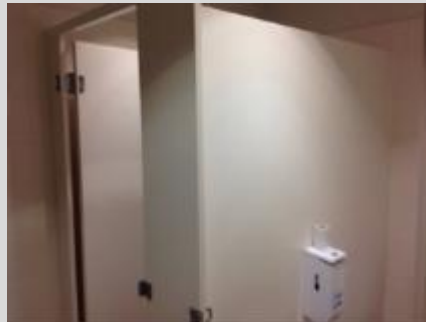
Elevation:	Level 3	Quantity:	4 - m2	Sample #:	Similar to 27296	
Position Installed:	Other - Refer to Comments	Condition:	-	Sample Result:	No Asbestos Detected	
Primary Location:	F2 - Committee rooms toilets (male)	Friability:	-	Risk Rating:		
Secondary Location:	Partitions	Surface Treatment:	-	Recommendation:	-	
Comments:	Toilet partitions					Urgent Action Required? -

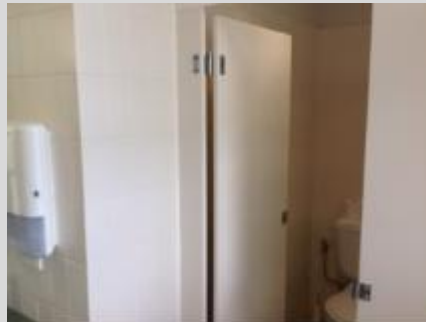
Elevation:	Level 3	Quantity:	5 - m2	Sample #:	Similar to 27297	
Position Installed:	Other - Refer to Comments	Condition:	-	Sample Result:	No Asbestos Detected	
Primary Location:	F3 - Committee room toilets (female)	Friability:	-	Risk Rating:		
Secondary Location:	Toilet doors	Surface Treatment:	-	Recommendation:	-	
Comments:	Epoxy coated timber					Urgent Action Required? -

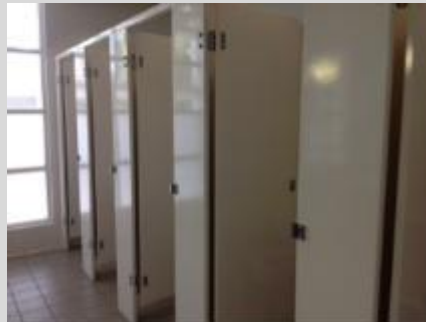
Elevation:	Level 3	Quantity:	13 - m2	Sample #:	Similar to 27297	
Position Installed:	Other - Refer to Comments	Condition:	-	Sample Result:	No Asbestos Detected	
Primary Location:	J4 - Public toilets (female)	Friability:	-	Risk Rating:		
Secondary Location:	Toilet doors	Surface Treatment:	-	Recommendation:	-	
Comments:	Epoxy coated timber					Urgent Action Required? -

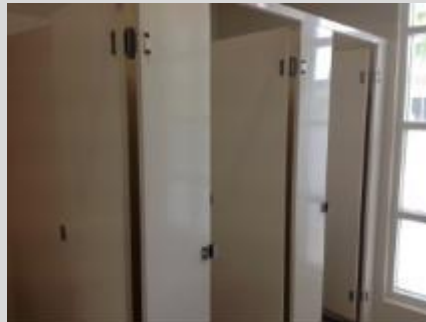
Elevation:	Level 3	Quantity:	10 - m2	Sample #:	Similar to 27297	
Position Installed:	Other - Refer to Comments	Condition:	-	Sample Result:	No Asbestos Detected	
Primary Location:	J5 - Public toilets (male)	Friability:	-	Risk Rating:		
Secondary Location:	Toilet doors	Surface Treatment:	-	Recommendation:	-	
Comments:	Epoxy coated timber					Urgent Action Required? -

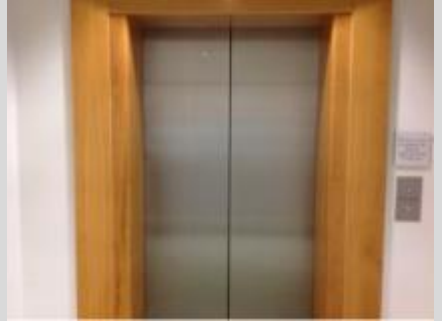
Elevation:	Level 3	Quantity:	0 - m2	Sample #:	-	
Position Installed:	Insulation / Fill	Condition:	Unknown	Sample Result:	-	
Primary Location:	Lift 1	Friability:	Unknown	Risk Rating:	5 - Moderate	
Secondary Location:	Fire proofing inside doors	Surface Treatment:	Unknown	Recommendation:	Manage & Review	
Comments:	Only authorized elevator maintenance technicians to access. If technician is to access, please contact Octief to discuss management and update details of register and management plan.					Urgent Action Required?
						No

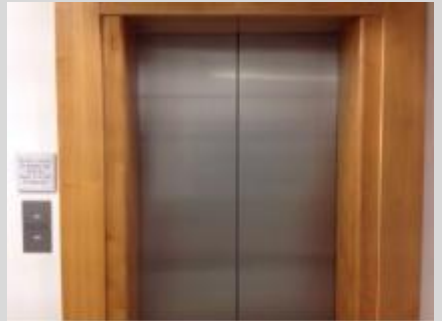
Elevation:	Level 3	Quantity:	0 - m2	Sample #:	-	
Position Installed:	Insulation / Fill	Condition:	Unknown	Sample Result:	-	
Primary Location:	Lift 2	Friability:	Unknown	Risk Rating:	5 - Moderate	
Secondary Location:	Fire proofing inside doors	Surface Treatment:	Unknown	Recommendation:	Manage & Review	
Comments:	Only authorized elevator maintenance technicians to access. If technician is to access, please contact Octief to discuss management and update details of register and management plan.					Urgent Action Required?
						No

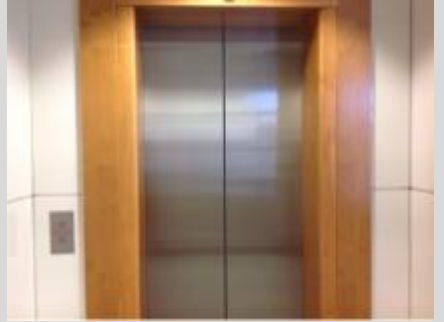
Elevation:	Level 3	Quantity:	0 - m2	Sample #:	-	
Position Installed:	Insulation / Fill	Condition:	Unknown	Sample Result:	-	
Primary Location:	Lift 3	Friability:	Unknown	Risk Rating:	5 - Moderate	
Secondary Location:	Fire proofing inside doors	Surface Treatment:	Unknown	Recommendation:	Manage & Review	
Comments:	Only authorized elevator maintenance technicians to access. If technician is to access, please contact Octief to discuss management and update details of register and management plan.					Urgent Action Required?
						No

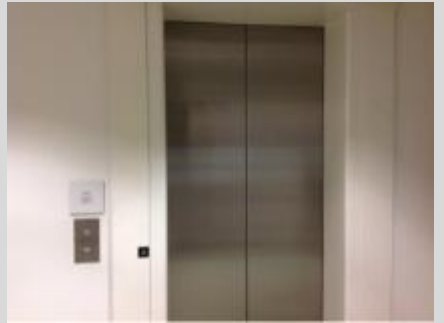
Elevation:	Level 3	Quantity:	0 - m2	Sample #:	-	
Position Installed:	Insulation / Fill	Condition:	Unknown	Sample Result:	-	
Primary Location:	Lift 4	Friability:	Unknown	Risk Rating:	5 - Moderate	
Secondary Location:	Fire proofing inside doors	Surface Treatment:	Unknown	Recommendation:	Manage & Review	
Comments:	Only authorized elevator maintenance technicians to access. If technician is to access, please contact Octief to discuss management and update details of register and management plan.					Urgent Action Required?
						No

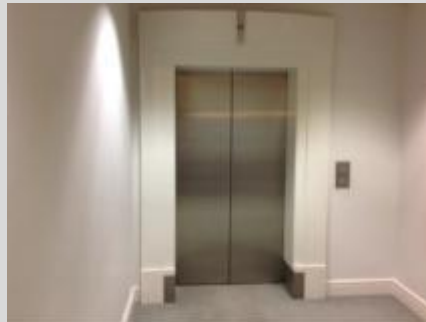
Elevation:	Level 3	Quantity:	0 - m2	Sample #:	-	
Position Installed:	Insulation / Fill	Condition:	Unknown	Sample Result:	-	
Primary Location:	Lift 5 - Goods lift	Friability:	Unknown	Risk Rating:	5 - Moderate	
Secondary Location:	Fire proofing inside doors	Surface Treatment:	Unknown	Recommendation:	Manage & Review	
Comments:	Only authorized elevator maintenance technicians to access. If technician is to access, please contact Octief to discuss management and update details of register and management plan.					Urgent Action Required?
						No

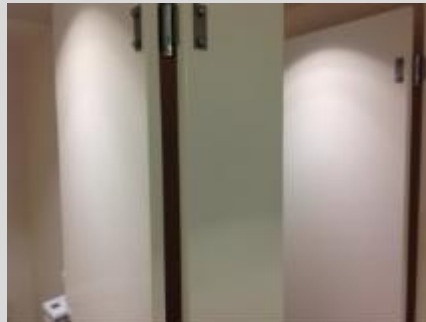
Elevation:	Level 4	Quantity:	5 - m2	Sample #:	Similar to 27297	
Position Installed:	Other - Refer to Comments	Condition:	-	Sample Result:	No Asbestos Detected	
Primary Location:	B2 - Lift 2 exit toilets (male)	Friability:	-	Risk Rating:		
Secondary Location:	Toilet doors	Surface Treatment:	-	Recommendation:	-	
Comments:	Epoxy coated timber					Urgent Action Required? -

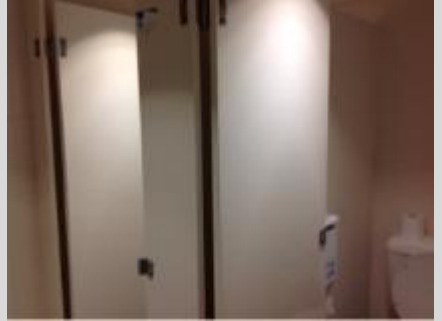
Elevation:	Level 4	Quantity:	5 - m2	Sample #:	Similar to 27297	
Position Installed:	Other - Refer to Comments	Condition:	-	Sample Result:	No Asbestos Detected	
Primary Location:	B5 - Lift 2 exit toilets (female)	Friability:	-	Risk Rating:		
Secondary Location:	Toilet doors	Surface Treatment:	-	Recommendation:	-	
Comments:	Epoxy coated timber					Urgent Action Required? -

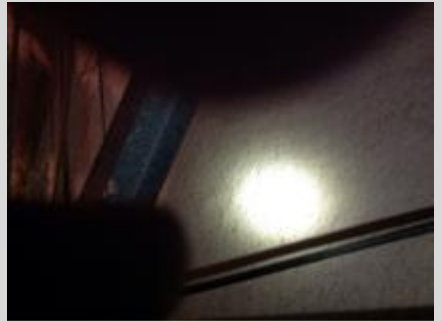
Elevation:	Level 4	Quantity:	0 - m2	Sample #:	27298	
Position Installed:	Insulation / Fill	Condition:	-	Sample Result:	No Asbestos Detected	
Primary Location:	Ceiling space	Friability:	-	Risk Rating:		
Secondary Location:	Purlins	Surface Treatment:	-	Recommendation:	-	
Comments:	Unknown quantity throughout building levels 4 and 5					Urgent Action Required? -

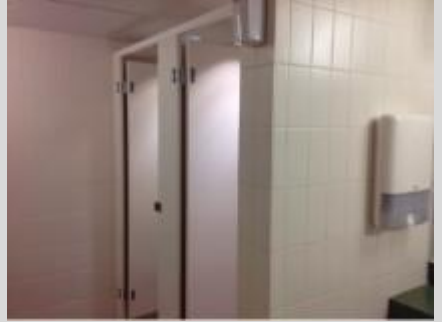
Elevation:	Level 4	Quantity:	4 - m2	Sample #:	Similar to 27296	
Position Installed:	Other - Refer to Comments	Condition:	-	Sample Result:	No Asbestos Detected	
Primary Location:	E3 - Members lounge toilets (male)	Friability:	-	Risk Rating:		
Secondary Location:	Partitions	Surface Treatment:	-	Recommendation:	-	
Comments:						Urgent Action Required? -

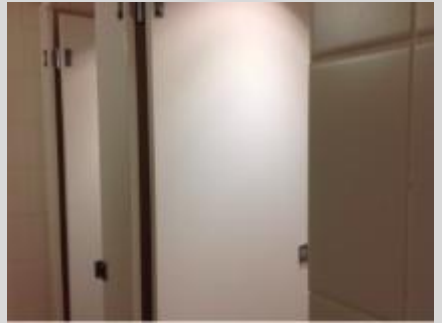
Elevation:	Level 4	Quantity:	5 - m2	Sample #:	Similar to 27297	
Position Installed:	Other - Refer to Comments	Condition:	-	Sample Result:	No Asbestos Detected	
Primary Location:	E3 - Members lounge toilets (male)	Friability:	-	Risk Rating:		
Secondary Location:	Toilet doors	Surface Treatment:	-	Recommendation:	-	
Comments:	Epoxy coated timber					Urgent Action Required? -

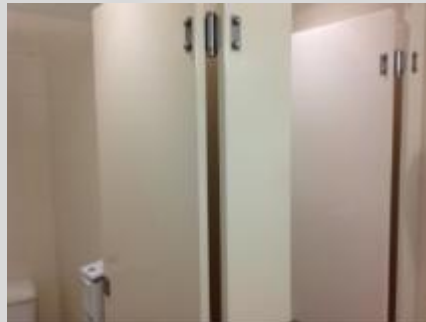
Elevation:	Level 4	Quantity:	7.5 - m2	Sample #:	Similar to 27297	
Position Installed:	Other - Refer to Comments	Condition:	-	Sample Result:	No Asbestos Detected	
Primary Location:	F6 - Kitchen toilets (female)	Friability:	-	Risk Rating:		
Secondary Location:	Toilet doors	Surface Treatment:	-	Recommendation:	-	
Comments:	Epoxy coated timber					Urgent Action Required?
						-

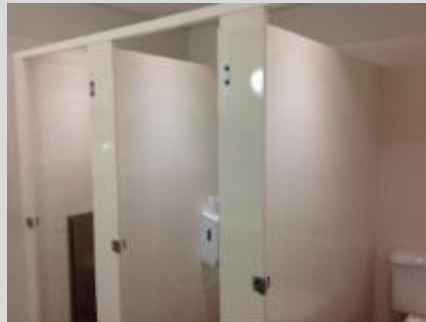
Elevation:	Level 4	Quantity:	8 - m2	Sample #:	Similar to 27296	
Position Installed:	Other - Refer to Comments	Condition:	-	Sample Result:	No Asbestos Detected	
Primary Location:	F7 - Kitchen toilets (male)	Friability:	-	Risk Rating:		
Secondary Location:	Partitions	Surface Treatment:	-	Recommendation:	-	
Comments:						Urgent Action Required? -

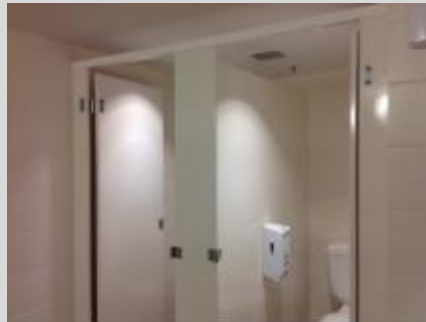
Elevation:	Level 4	Quantity:	4 - m2	Sample #:	Similar to 27296	
Position Installed:	Other - Refer to Comments	Condition:	-	Sample Result:	No Asbestos Detected	
Primary Location:	H5 - Members dining room toilets (male)	Friability:	-	Risk Rating:		
Secondary Location:	Partitions	Surface Treatment:	-	Recommendation:	-	
Comments:						Urgent Action Required? -

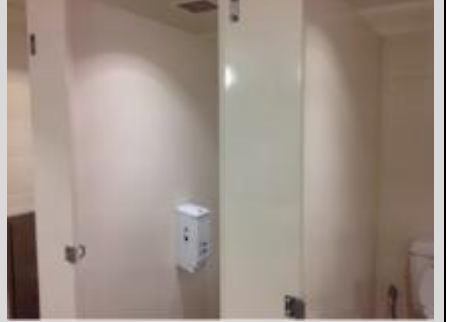
Elevation:	Level 4	Quantity:	8 - m2	Sample #:	Similar to 27296	
Position Installed:	Other - Refer to Comments	Condition:	-	Sample Result:	No Asbestos Detected	
Primary Location:	H7 - Members dining room toilets (female)	Friability:	-	Risk Rating:		
Secondary Location:	Partitions	Surface Treatment:	-	Recommendation:	-	
Comments:						Urgent Action Required? -
