Ref: OGCAA3591 – Parliament House Darwin

ASBESTOS MANAGEMENT PLAN FOR Parliament House Darwin

**NORTHERN TERRITORY PARLIAMENT
HOUSE**

ASBESTOS MANAGEMENT PLAN

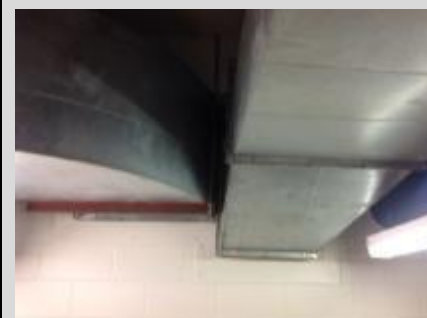
Location Details		Material Details		Results / Management Details		Photographs
Building ID:	Parliament House	Material Type:	Adhesive	Status:	Not Present (Tested)

Elevation:	Level 1	Quantity:	1 - 1m	Sample #:	27295	
Position Installed:	Membrane	Condition:	-	Sample Result:	No Asbestos Detected	
Primary Location:	A1 - Housekeeping staff room	Friability:	-	Risk Rating:		
Secondary Location:	Sealant to Ductwork	Surface Treatment:	-	Recommendation:	-	
Comments:						Urgent Action Required? -

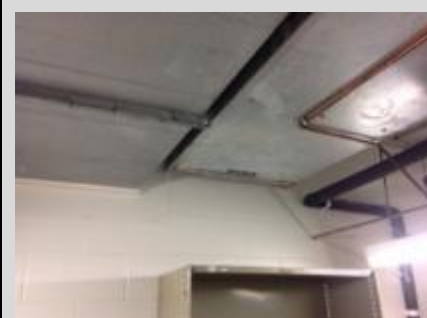
Location Details		Material Details		Results / Management Details		Photographs
Building ID:	Parliament House	Material Type:	Adhesive	Status:	Not Present (Tested)

Elevation:	Level 1	Quantity:	1 - 1m	Sample #:	27294	
Position Installed:	Membrane	Condition:	-	Sample Result:	No Asbestos Detected	
Primary Location:	A1 - Housekeeping staff room	Friability:	-	Risk Rating:		
Secondary Location:	Sealant to AHU5	Surface Treatment:	-	Recommendation:	-	
Comments:						Urgent Action Required? -

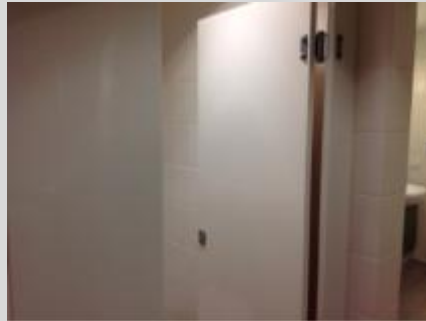
Location Details		Material Details		Results / Management Details		Photographs
Building ID:	Parliament House	Material Type:	Other - Refer to Comments	Status:	Not Present (Not Tested)

Elevation:	Level 3	Quantity:	10 - m2	Sample #:	Similar to 27297	
Position Installed:	Other - Refer to Comments	Condition:	-	Sample Result:	No Asbestos Detected	
Primary Location:	F2 - Committee rooms toilets (male)	Friability:	-	Risk Rating:		
Secondary Location:	Toilet doors	Surface Treatment:	-	Recommendation:	-	
Comments:	Epoxy coated timber					Urgent Action Required? -

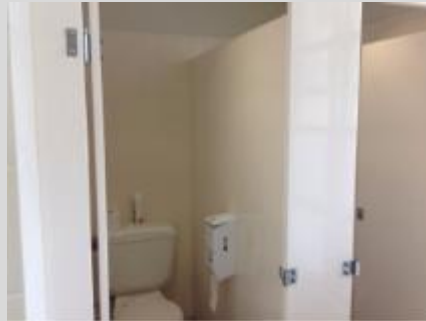
Location Details		Material Details		Results / Management Details		Photographs
Building ID:	Parliament House	Material Type:	Cement Based	Status:	Not Present (Not Tested)

Elevation:	Level 3	Quantity:	4 - m2	Sample #:	Similar to 27296	
Position Installed:	Other - Refer to Comments	Condition:	-	Sample Result:	No Asbestos Detected	
Primary Location:	F3 - Committee rooms toilets (female)	Friability:	-	Risk Rating:		
Secondary Location:	Partitions	Surface Treatment:	-	Recommendation:	-	
Comments:						Urgent Action Required? -

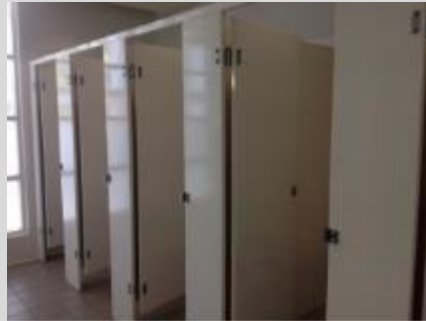
Location Details		Material Details		Results / Management Details		Photographs
Building ID:	Parliament House	Material Type:	Cement Based	Status:	Not Present (Not Tested)

Elevation:	Level 3	Quantity:	16 - m2	Sample #:	Similar to 27296	
Position Installed:	Other - Refer to Comments	Condition:	-	Sample Result:	No Asbestos Detected	
Primary Location:	J4 - Public toilets (female)	Friability:	-	Risk Rating:		
Secondary Location:	Partitions	Surface Treatment:	-	Recommendation:	-	
Comments:						Urgent Action Required? -

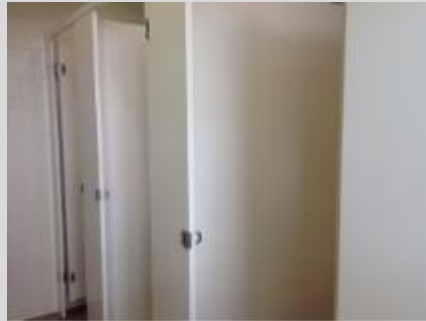
Location Details		Material Details		Results / Management Details		Photographs
Building ID:	Parliament House	Material Type:	Cement Based	Status:	Not Present (Not Tested)

Elevation:	Level 3	Quantity:	12 - m2	Sample #:	Similar to 27296	
Position Installed:	Other - Refer to Comments	Condition:	-	Sample Result:	No Asbestos Detected	
Primary Location:	J5 - Public toilets (male)	Friability:	-	Risk Rating:		
Secondary Location:	Partitions	Surface Treatment:	-	Recommendation:	-	
Comments:	Toilet partitions					Urgent Action Required? -

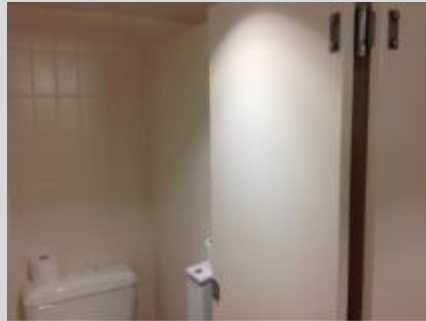
Location Details		Material Details		Results / Management Details		Photographs
Building ID:	Parliament House	Material Type:	Cement Based	Status:	Not Present (Not Tested)

Elevation:	Level 4	Quantity:	4 - m2	Sample #:	Similar to 27296	
Position Installed:	Other - Refer to Comments	Condition:	-	Sample Result:	No Asbestos Detected	
Primary Location:	B2 - Lift 2 exit toilets (male)	Friability:	-	Risk Rating:		
Secondary Location:	Partitions	Surface Treatment:	-	Recommendation:	-	
Comments:						Urgent Action Required?
						-

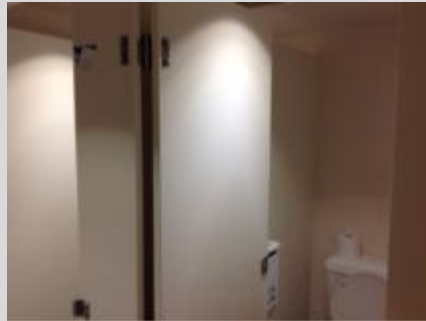
Location Details		Material Details		Results / Management Details		Photographs
Building ID:	Parliament House	Material Type:	Cement Based	Status:	Not Present (Not Tested)

Elevation:	Level 4	Quantity:	4 - m2	Sample #:	Similar to 27296	
Position Installed:	Other - Refer to Comments	Condition:	-	Sample Result:	No Asbestos Detected	
Primary Location:	B5 - Lift 2 exit toilets (female)	Friability:	-	Risk Rating:		
Secondary Location:	Partitions	Surface Treatment:	-	Recommendation:	-	
Comments:						Urgent Action Required? -

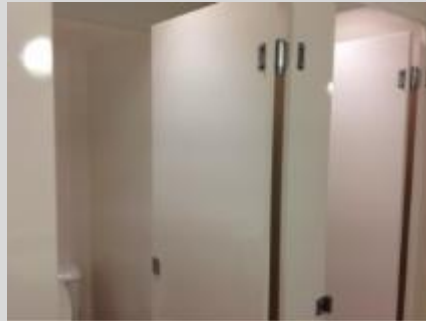
Location Details		Material Details		Results / Management Details		Photographs
Building ID:	Parliament House	Material Type:	Other - Refer to Comments	Status:	Not Present (Not Tested)

Elevation:	Level 4	Quantity:	7.5 - m2	Sample #:	Similar to 27297	
Position Installed:	Other - Refer to Comments	Condition:	-	Sample Result:	No Asbestos Detected	
Primary Location:	F6 - Kitchen toilets (female)	Friability:	-	Risk Rating:		
Secondary Location:	Toilet doors	Surface Treatment:	-	Recommendation:	-	
Comments:	Epoxy coated timber					Urgent Action Required?
						-

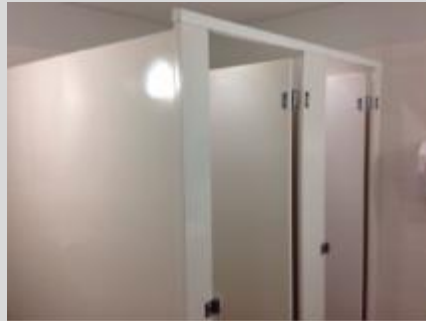
Location Details		Material Details		Results / Management Details		Photographs
Building ID:	Parliament House	Material Type:	Cement Based	Status:	Not Present (Not Tested)

Elevation:	Level 4	Quantity:	8 - m2	Sample #:	Similar to 27296	
Position Installed:	Other - Refer to Comments	Condition:	-	Sample Result:	No Asbestos Detected	
Primary Location:	F7 - Kitchen toilets (male)	Friability:	-	Risk Rating:		
Secondary Location:	Partitions	Surface Treatment:	-	Recommendation:	-	
Comments:						Urgent Action Required? -

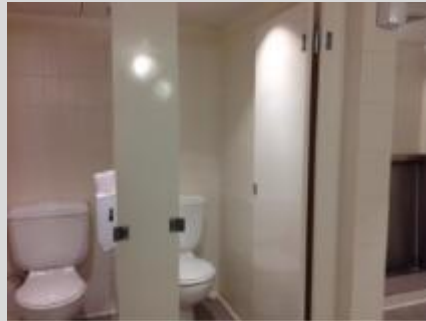
Location Details		Material Details		Results / Management Details		Photographs
Building ID:	Parliament House	Material Type:	Other - Refer to Comments	Status:	Not Present (Not Tested)

Elevation:	Level 4	Quantity:	5 - m2	Sample #:	Similar to 27297	
Position Installed:	Other - Refer to Comments	Condition:	-	Sample Result:	No Asbestos Detected	
Primary Location:	H5 - Members dining room toilets (male)	Friability:	-	Risk Rating:		
Secondary Location:	Toilet doors	Surface Treatment:	-	Recommendation:	-	
Comments:	Epoxy coated timber					Urgent Action Required? -

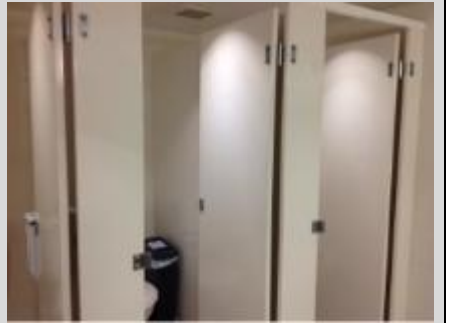
Location Details		Material Details		Results / Management Details		Photographs
Building ID:	Parliament House	Material Type:	Other - Refer to Comments	Status:	Not Present (Not Tested)

Elevation:	Level 4	Quantity:	7.5 - m2	Sample #:	Similar to 27297	
Position Installed:	Other - Refer to Comments	Condition:	-	Sample Result:	No Asbestos Detected	
Primary Location:	H7 - Members dining room toilets (female)	Friability:	-	Risk Rating:		
Secondary Location:	Toilet doors	Surface Treatment:	-	Recommendation:	-	
Comments:	Epoxy coated timber					Urgent Action Required? -

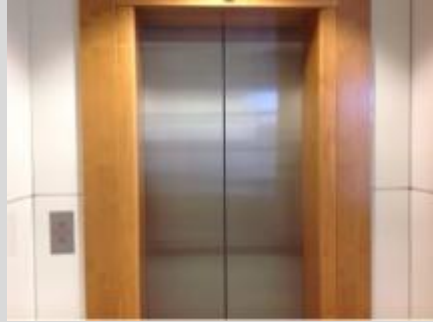
Location Details		Material Details		Results / Management Details		Photographs
Building ID:	Parliament House	Material Type:	Other - Refer to Comments	Status:	Presumed

Elevation:	Level 4	Quantity:	0 - m2	Sample #:	-	
Position Installed:	Insulation / Fill	Condition:	Unknown	Sample Result:	-	
Primary Location:	Lift 3	Friability:	Unknown	Risk Rating:	5 - Moderate	
Secondary Location:	Fire proofing inside doors	Surface Treatment:	Unknown	Recommendation:	Manage & Review	
Comments:	Only authorized elevator maintenance technicians to access. If technician is to access, please contact Octief to discuss management and update details of register and management plan.					Urgent Action Required?
						No

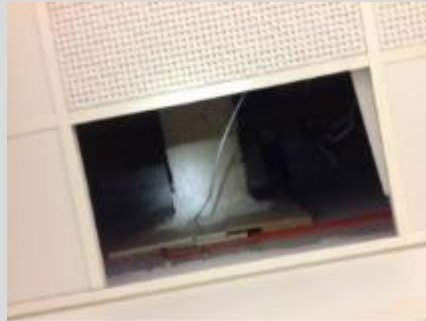
Location Details		Material Details		Results / Management Details		Photographs
Building ID:	Parliament House	Material Type:	Spray Coating	Status:	Not Present (Not Tested)

Elevation:	Level 5	Quantity:	0 - m2	Sample #:	Similar 27298	
Position Installed:	Insulation / Fill	Condition:	-	Sample Result:	No Asbestos Detected	
Primary Location:	Ceiling space	Friability:	-	Risk Rating:		
Secondary Location:	Purlins	Surface Treatment:	-	Recommendation:	-	
Comments:	Unknown quantity throughout building levels 4 and 5					Urgent Action Required?
						-

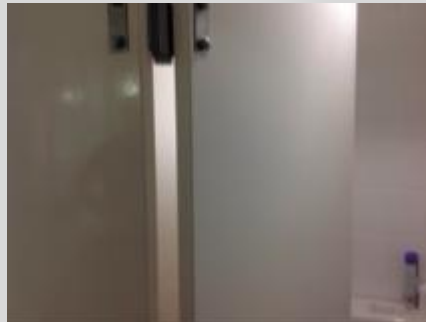
Location Details		Material Details		Results / Management Details		Photographs
Building ID:	Parliament House	Material Type:	Other - Refer to Comments	Status:	Not Present (Not Tested)

Elevation:	Level 5	Quantity:	5 - m2	Sample #:	Similar to 27297	
Position Installed:	Other - Refer to Comments	Condition:	-	Sample Result:	No Asbestos Detected	
Primary Location:	J2 - Northern Corridor toilets (female)	Friability:	-	Risk Rating:		
Secondary Location:	Toilet doors	Surface Treatment:	-	Recommendation:	-	
Comments:	Epoxy coated timber					Urgent Action Required? -

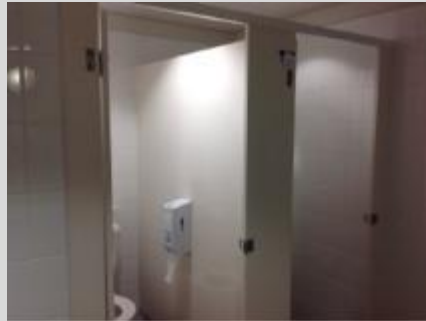
Location Details		Material Details		Results / Management Details		Photographs
Building ID:	Parliament House	Material Type:	Cement Based	Status:	Not Present (Not Tested)

Elevation:	Level 5	Quantity:	4 - m2	Sample #:	Similar to 27296	
Position Installed:	Other - Refer to Comments	Condition:	-	Sample Result:	No Asbestos Detected	
Primary Location:	J2 - Northern Corridor toilets (female)	Friability:	-	Risk Rating:		
Secondary Location:	Partitions	Surface Treatment:	-	Recommendation:	-	
Comments:						Urgent Action Required? -

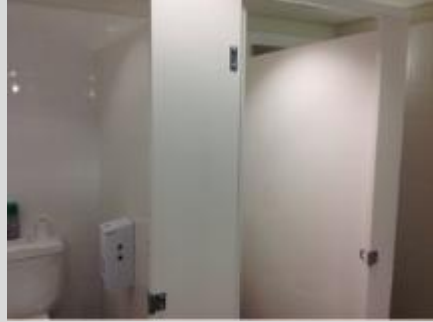
Location Details		Material Details		Results / Management Details		Photographs
Building ID:	Parliament House	Material Type:	Cement Based	Status:	Not Present (Not Tested)

Elevation:	Level 5	Quantity:	8 - m2	Sample #:	Similar to 27296	
Position Installed:	Other - Refer to Comments	Condition:	-	Sample Result:	No Asbestos Detected	
Primary Location:	J3 - Northern Corridor toilets (male)	Friability:	-	Risk Rating:		
Secondary Location:	Partitions	Surface Treatment:	-	Recommendation:	-	
Comments:						<div>Urgent Action Required?</div> <div>-</div>

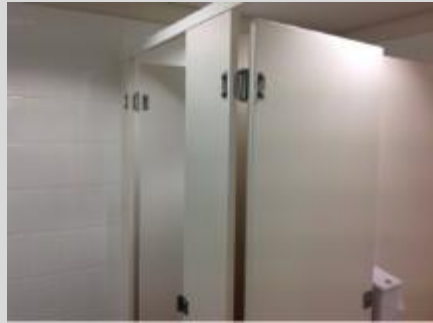
Location Details		Material Details		Results / Management Details		Photographs
Building ID:	Parliament House	Material Type:	Other - Refer to Comments	Status:	Not Present (Not Tested)

Elevation:	Level 5	Quantity:	5 - m2	Sample #:	Similar to 27297	
Position Installed:	Other - Refer to Comments	Condition:	-	Sample Result:	No Asbestos Detected	
Primary Location:	J3 - Northern Corridor toilets (male)	Friability:	-	Risk Rating:		
Secondary Location:	Toilet doors	Surface Treatment:	-	Recommendation:	-	
Comments:	Epoxy coated timber					<div>Urgent Action Required?</div> <div>-</div>

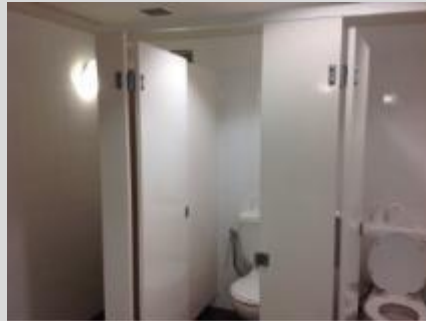
Location Details		Material Details		Results / Management Details		Photographs
Building ID:	Parliament House	Material Type:	Cement Based	Status:	Not Present (Not Tested)

Elevation:	Level 5	Quantity:	8 - m2	Sample #:	Similar to 27296	
Position Installed:	Other - Refer to Comments	Condition:	-	Sample Result:	No Asbestos Detected	
Primary Location:	N2 - Southern Corridor toilets (male)	Friability:	-	Risk Rating:		
Secondary Location:	Partitions	Surface Treatment:	-	Recommendation:	-	
Comments:						Urgent Action Required?
						-

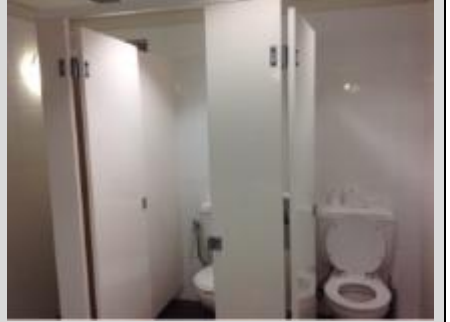
Location Details		Material Details		Results / Management Details		Photographs
Building ID:	Parliament House	Material Type:	Other - Refer to Comments	Status:	Not Present (Not Tested)

Elevation:	Level 5	Quantity:	5 - m2	Sample #:	Similar to 27297	
Position Installed:	Other - Refer to Comments	Condition:	-	Sample Result:	No Asbestos Detected	
Primary Location:	N2 - Southern Corridor toilets (male)	Friability:	-	Risk Rating:		
Secondary Location:	Toilet doors	Surface Treatment:	-	Recommendation:	-	
Comments:	Epoxy coated timber					Urgent Action Required? -

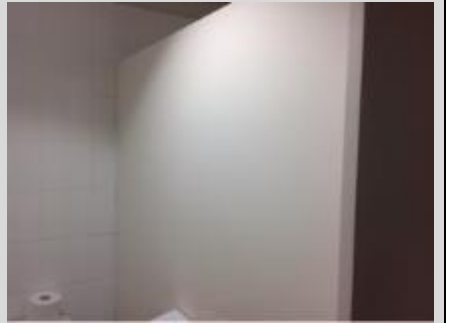
Location Details		Material Details		Results / Management Details		Photographs
Building ID:	Parliament House	Material Type:	Cement Based	Status:	Not Present (Not Tested)

Elevation:	Level 5	Quantity:	4 - m2	Sample #:	Similar to 27296	
Position Installed:	Other - Refer to Comments	Condition:	-	Sample Result:	No Asbestos Detected	
Primary Location:	N3 - Southern Corridor toilets (female)	Friability:	-	Risk Rating:		
Secondary Location:	Partitions	Surface Treatment:	-	Recommendation:	-	
Comments:						Urgent Action Required? -

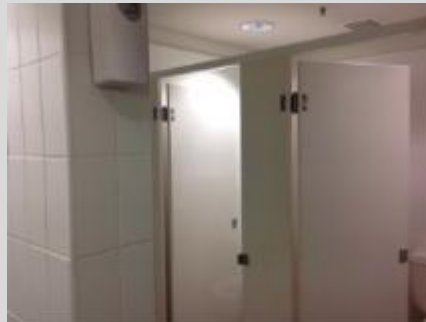
Location Details		Material Details		Results / Management Details		Photographs
Building ID:	Parliament House	Material Type:	Other - Refer to Comments	Status:	Not Present (Not Tested)

Elevation:	Level 5	Quantity:	5 - m2	Sample #:	Similar to 27297	
Position Installed:	Other - Refer to Comments	Condition:	-	Sample Result:	No Asbestos Detected	
Primary Location:	N3 - Southern Corridor toilets (female)	Friability:	-	Risk Rating:		
Secondary Location:	Toilet doors	Surface Treatment:	-	Recommendation:	-	
Comments:	Epoxy coated timber					Urgent Action Required? -

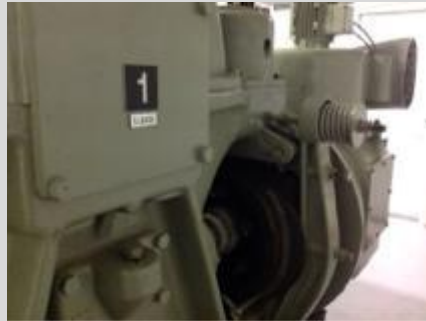
Location Details		Material Details		Results / Management Details		Photographs
Building ID:	Parliament House	Material Type:	Other - Refer to Comments	Status:	Presumed

Elevation:	Level 6	Quantity:	2 No.	Sample #:	-	
Position Installed:	Friction Product	Condition:	Good	Sample Result:	-	
Primary Location:	A3 - Lift motor 1	Friability:	Friable	Risk Rating:	5 - Moderate	
Secondary Location:	Brake pads	Surface Treatment:	Unsealed	Recommendation:	Manage & Review	
Comments:	Brake pads					Urgent Action Required? No

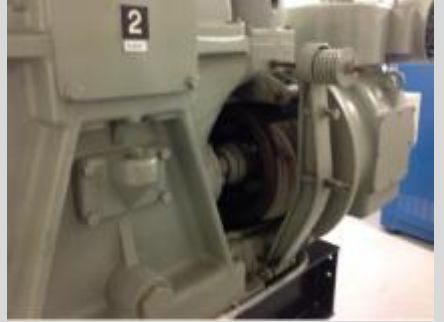
Location Details		Material Details		Results / Management Details		Photographs
Building ID:	Parliament House	Material Type:	Other - Refer to Comments	Status:	Presumed

Elevation:	Level 6	Quantity:	2 No.	Sample #:	-	
Position Installed:	Friction Product	Condition:	Good	Sample Result:	-	
Primary Location:	A4 - Lift motor 2	Friability:	Friable	Risk Rating:	5 - Moderate	
Secondary Location:	Brake pads	Surface Treatment:	Unsealed	Recommendation:	Manage & Review	
Comments:	Brake pads					Urgent Action Required? No

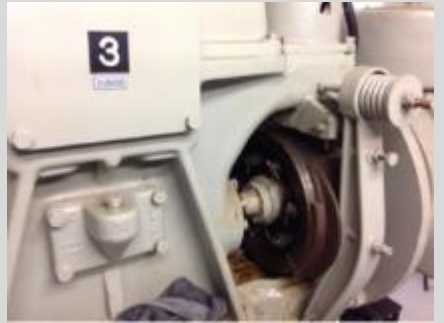
Location Details		Material Details		Results / Management Details		Photographs
Building ID:	Parliament House	Material Type:	Other - Refer to Comments	Status:	Presumed

Elevation:	Level 6	Quantity:	2 No.	Sample #:	-	
Position Installed:	Friction Product	Condition:	Good	Sample Result:	-	
Primary Location:	A5 - Lift motor 3	Friability:	Friable	Risk Rating:	5 - Moderate	
Secondary Location:	Brake pads	Surface Treatment:	Unsealed	Recommendation:	Manage & Review	
Comments:	Brake pads					Urgent Action Required? No

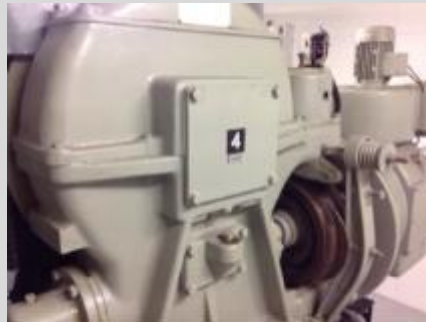
Location Details		Material Details		Results / Management Details		Photographs
Building ID:	Parliament House	Material Type:	Other - Refer to Comments	Status:	Presumed

Elevation:	Level 6	Quantity:	2 No.	Sample #:	-	
Position Installed:	Friction Product	Condition:	Good	Sample Result:	-	
Primary Location:	A5 - Lift motor 4	Friability:	Friable	Risk Rating:	5 - Moderate	
Secondary Location:	Brake pads	Surface Treatment:	Unsealed	Recommendation:	Manage & Review	
Comments:	Brake pads					Urgent Action Required? No

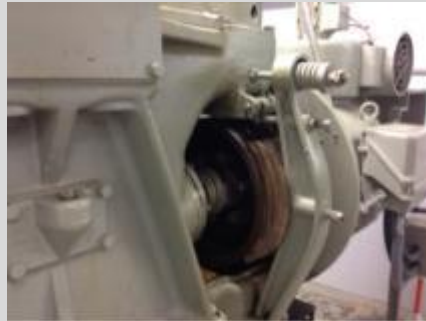
Location Details		Material Details		Results / Management Details		Photographs
Building ID:	Parliament House	Material Type:	Other - Refer to Comments	Status:	Presumed

Elevation:	Level 6	Quantity:	2 No.	Sample #:	-	
Position Installed:	Friction Product	Condition:	Good	Sample Result:	-	
Primary Location:	A6 - Lift motor 5	Friability:	Friable	Risk Rating:	5 - Moderate	
Secondary Location:	Brake pads	Surface Treatment:	Unsealed	Recommendation:	Manage & Review	
Comments:	Brake pads					Urgent Action Required? No

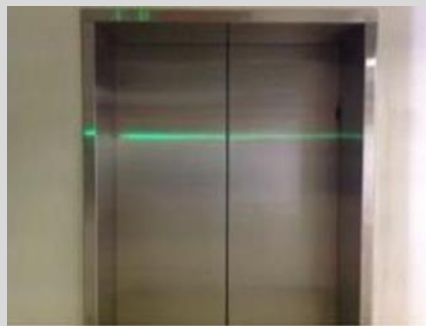
Location Details		Material Details		Results / Management Details		Photographs
Building ID:	Parliament House	Material Type:	Other - Refer to Comments	Status:	Presumed

Elevation:	Level 6	Quantity:	0 - m2	Sample #:	-	
Position Installed:	Insulation / Fill	Condition:	Unknown	Sample Result:	-	
Primary Location:	Lift 5 - Goods lift	Friability:	Unknown	Risk Rating:	5 - Moderate	
Secondary Location:	Fire proofing inside doors	Surface Treatment:	Unknown	Recommendation:	Manage & Review	
Comments:	Only authorized elevator maintenance technicians to access. If technician is to access, please contact Octief to discuss management and update details of register and management plan.					Urgent Action Required?
						No
Location Details		Material Details		Results / Management Details		Photographs
Building ID:	Parliament House	Material Type:	Adhesive	Status:	Not Present (Not Tested)

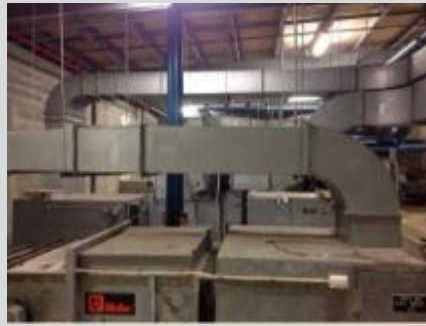
Elevation:	Level 6	Quantity:	400 - lm	Sample #:	Similar to 27291

Position Installed:	Membrane	Condition:	-	Sample Result:	No Asbestos Detected	
Primary Location:	Plantroom 5 - All AHUs and Chillers	Friability:	-	Risk Rating:		
Secondary Location:	Joint sealant	Surface Treatment:	-	Recommendation:	-	
Comments:						Urgent Action Required?
						-
